TECHNICAL REPORT REMR CO-3

CASE HISTORIES OF CORPS BREAKWATER
AND JETTY STRUCTURES

Report 1
SOUTH PACIFIC DIVISION

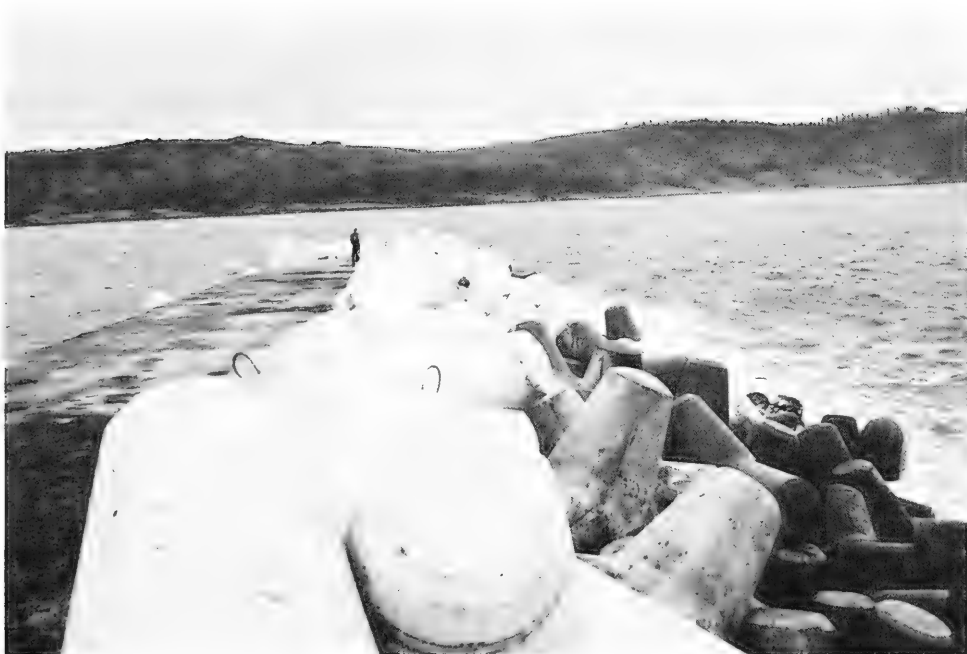
Figure 5. View of tetrapods at head of Crescent City
Harbor outer breakwater

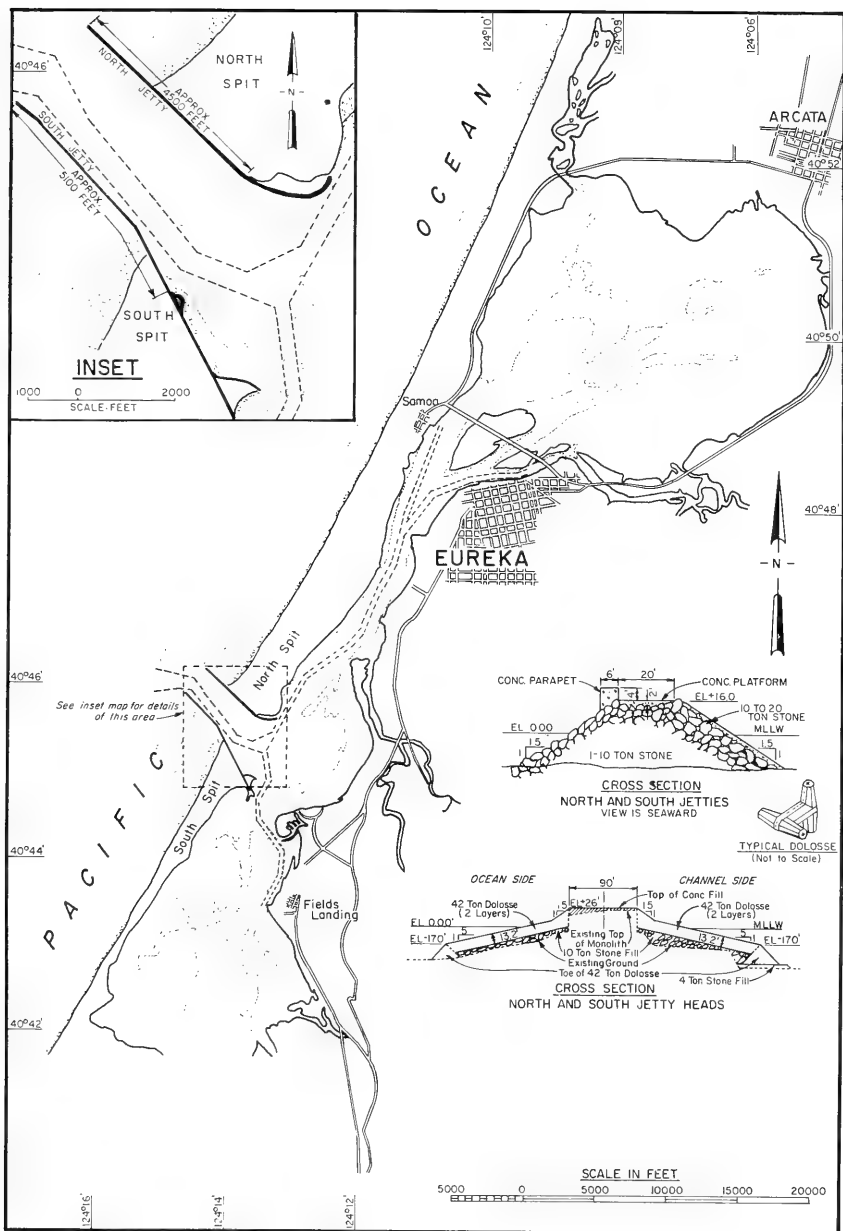
Figure 6. Humboldt Harbor and Bay, California

1937	South jetty repairs using 1,552 cu yd of concrete were completed at a cost of \$25,400.
1939	Heavy storms caused great damage to both jetties. The monoliths at the outer end of the south jetty were undermined, causing them to tilt and sink. Breaches occurred in the jetty immediately shoreward of the monolithic end. A partial breach occurred through the north jetty just shoreward of its monolithic end. In addition, considerable damage was done to the side slopes of both jetties. During the year south jetty repairs were completed using 12,450 cu yd of concrete at a cost of \$151,025.
1940	North jetty repairs using 7,418 cu yd of concrete and 2,200 tons of stone and south jetty repairs using 29,772 cu yd of concrete were completed at a cost of \$311,848.
1941	North jetty repairs using 15,158 cu yd of concrete and 1,705 tons of stone were completed at a cost of \$141,220.
1942	North jetty repairs using 8,809 cu yd of concrete were completed for a cost of \$124,220.

1957- 1958	Severe winter storms deteriorated the north and south jetties to such an extent that repair work constituted a major construction project.
1958	Mass concrete was poured to fill eroded areas on crests, and armor stones were replaced in areas that were breached and washed out. Concrete blocks (11 by 11 ft) weighing 100 tons and 12-ton tetrahedrons were placed on the heads of both jetties.
1959	Major side slope losses on the south sides of both the north and south jetties occurred.
1960- 1963	Rehabilitation of both jetties was accomplished. Jetty trunks were repaired with 12-ton stones placed on 1V:1.5H slopes in the eroded areas. Jetty heads were reconstructed using 20-ton blocks to form head perimeters, and centers were filled with mass concrete. Two-hundred and fifty 100-ton concrete blocks were placed around the seaward tip of the south jetty head. The concrete monolith at

Date(s)	Construction and Rehabilitation History
	seaward end of the north jetty was completed in 1961 and within the year was undermined by wave action resulting in part of the monolith breaking off. The monolith was repaired by placing rocks around the head section on 1V:2H side slopes and grouting the rocks with concrete. The elevation of the concrete at the north jetty was raised to +25 ft mllw and at the south jetty to +26 ft mllw at the tip. The heads were protected with 12-ton stones with a cover layer of 100-ton concrete blocks.
1963-1965	Winter storm waves washed away most of the newly placed 100-ton concrete blocks.
1969-1970	The concrete monolith at south jetty was undermined and broken. Heads of both jetties were totally destroyed.
1971-1972	Rehabilitation of both jetties was completed. Concrete monoliths were reconstructed, and 42-ton dolosse were placed around the seaward quadrant of both jetty heads. Four unreinforced, 1,271 steel-reinforced, and 17 steel-fiber-reinforced dolosse were placed on the north jetty; and 22 unreinforced and 1,423 steel-reinforced dolosse were placed on the south jetty head. Dolosse (43-ton) also were placed on the shoreward transition sections of both jetty heads. Two layers of dolosse were placed using a concentration of 11 dolosse per 1,000 sq ft of slope. Cost of this work was \$10,108,764. Model testing was conducted prior to these repairs (Davidson 1971).

1973	South jetty repairs using concrete and stone were completed at a cost of \$20,400.
1975	An earthquake of 5.2 magnitude on the Richter scale occurred near the site. Inspection trips subsequent to the earthquake revealed fresh cracks along the south jetty running along the edges of the crest and slope for a distance of about 800 ft on the channel side and 300 ft on the seaward side. Blowout holes also were observed at several locations on the south jetty. On the north jetty, three of the dolosse had moved about 50, 100, and 150 ft from the placement area, respectively. Only minor settling of the remaining dolosse had occurred, and no cracking or unraveling of the dolosse units was apparent.
1977	South jetty repairs using concrete and rock were completed. Approximately 15,000 tons of stone ranging from 1 to 20 tons were used for these repairs.
1977-1978	The jetties were subjected to severe storms combined with high tides and winds. On occasion, waves covered both jetties over their entire lengths. Waves also were observed breaking over the dolosse and concrete monoliths of the jetty heads. North jetty repairs using stone were completed at a cost of \$450,000.

Date(s)	Construction and Rehabilitation History
1978	An inspection revealed that the north jetty slope was eroded at several locations, and 12 blowout holes were apparent in the concrete cap. Also, at the north jetty head, waves had broken away a 20-ton concrete block from the concrete monolith which washed across the monolith and was resting against a tip of a dolos. The slope of the south jetty had eroded in numerous locations, and the parapet wall had broken at four stations. Nineteen blowout holes were observed in the south jetty concrete cap. Also a 7-ft stone had broken out of the parapet wall and was deposited on the concrete cap.
1983	Major storms resulted in an estimated \$2,000,000 in damages to the jetties.
1984	Repair of the south jetty consisting of 4,900 tons of 15- to 25-ton stones and replacement of 20-ton concrete blocks at the jetty head was completed. Also 16,665 tons of 15- to 25-ton stones and 16,665 tons of 18- to 31-ton stones were stockpiled on the harbor side of the jetty.

1985	Repair of the jetty heads was completed using a total of approximately 1,000 42-ton dolosse in various areas and the construction of toe berms.

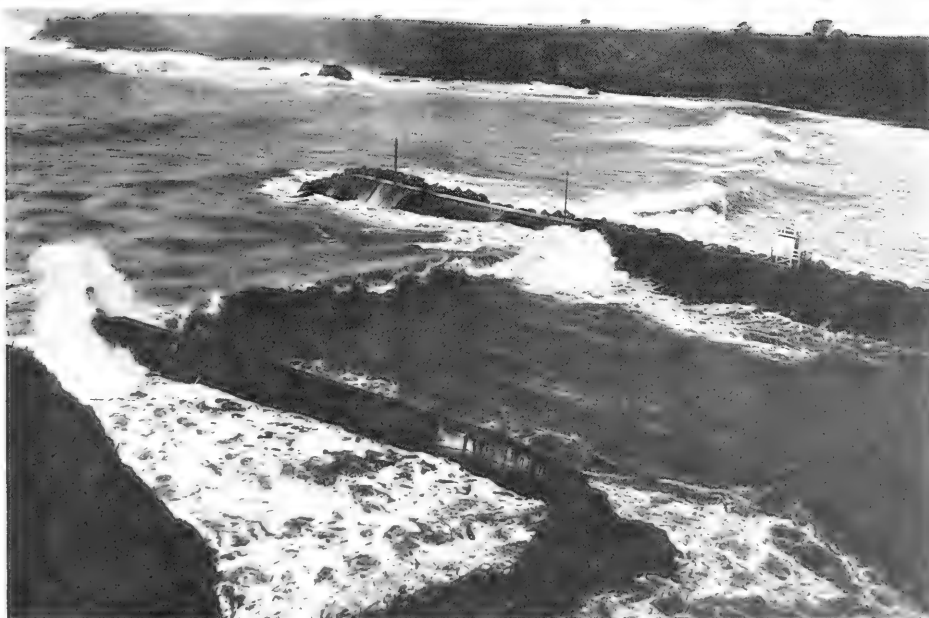
Figure 8. View of the jetties at Noyo River entrance

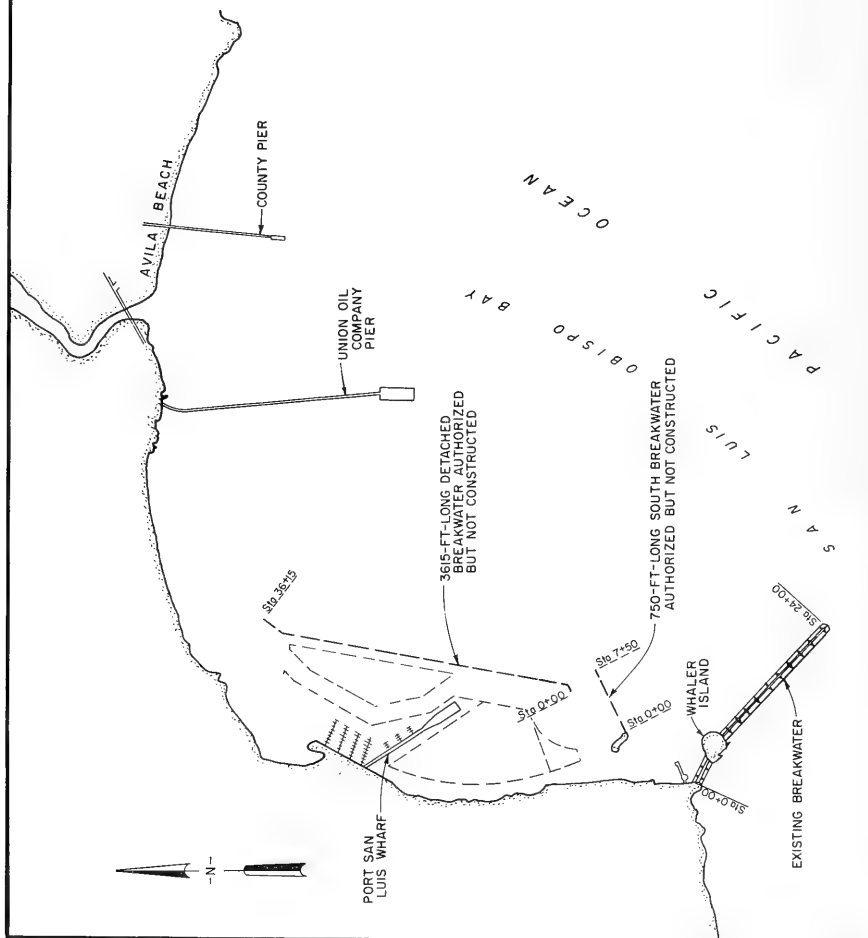
Figure 22. Port San Luis, California

1983	Major storms resulted in approximately \$578,000 in damages to the breakwater.
1984	Maintenance repair of the existing breakwater was completed which consisted of approximately 8,700 tons of capstone placement and resetting of 40 existing capstone. The crest width of the structure was increased to 20 ft. Plans and specifications for construction of the modified project (authorized in 1976) were about 80 percent complete.
1986	The breakwater currently is in satisfactory condition.
